The Story of Those Pistons

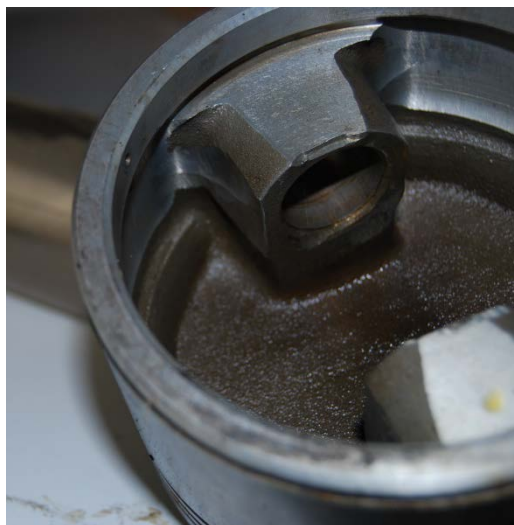
The pistons found in my engine were of a type Al Holloway had seen before. Out of 14 pistons in two sets, 13 pistons had cracks in under 200 hours of service. Looking at the pistons removed from the engine it was not difficult to tell why. The pistons were of an inferior casting process (actual alloy unknown) that led to a poor grain structure. As a result, some areas of the piston broke off without any apparent physical interference. (See flake off bottom of pin boss in photo below.)

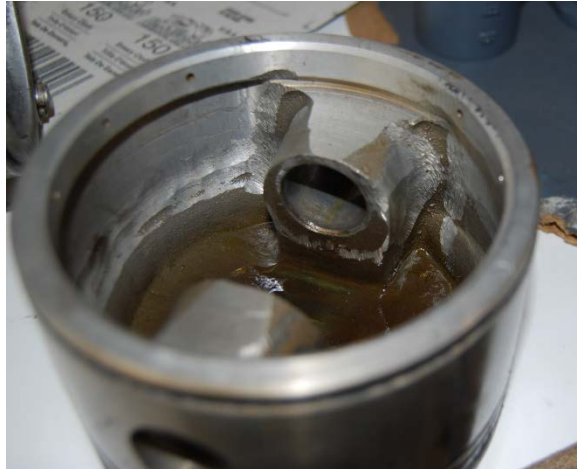
In addition to the inferior molding, whoever prepared the pistons in my plane attempted to establish and equalize required weight by grinding out material inside some pistons with a hand-held die grinder and bounced it all over the insides of the pistons. The photo below is typical. No wonder cracks started with all those stress risers being pounded.

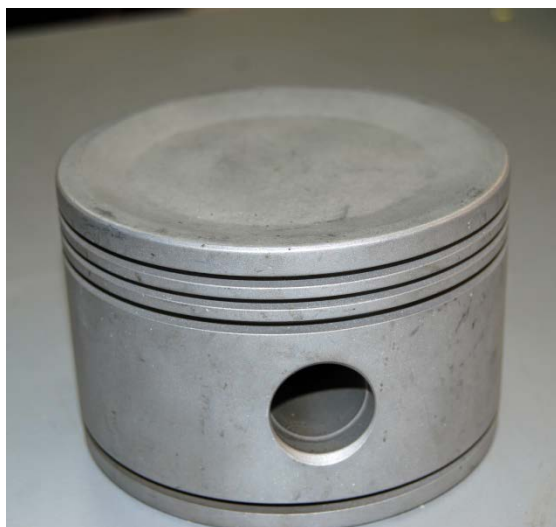
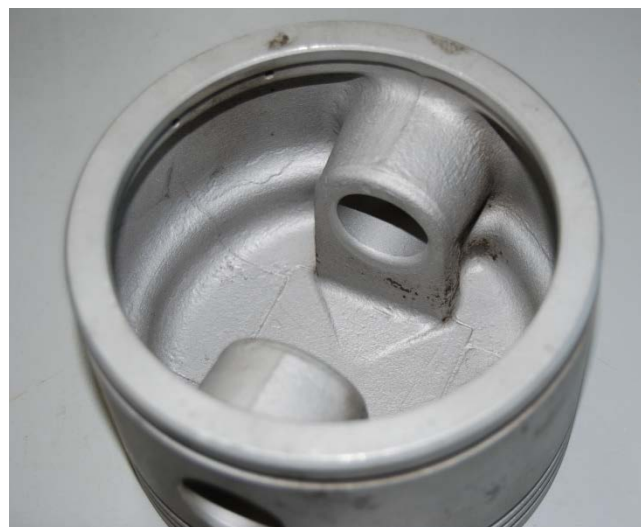
Good used original pistons would have been preferred because of compatibility and cost but none could be found. The difficulty in finding used original pistons might have been what led people to use the deficient counterfeit ones like in my engine. The following two pictures show what the original piston looked like inside and out.

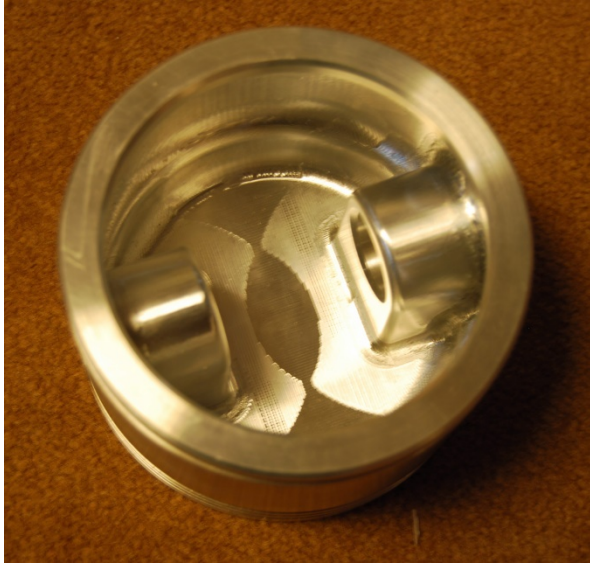
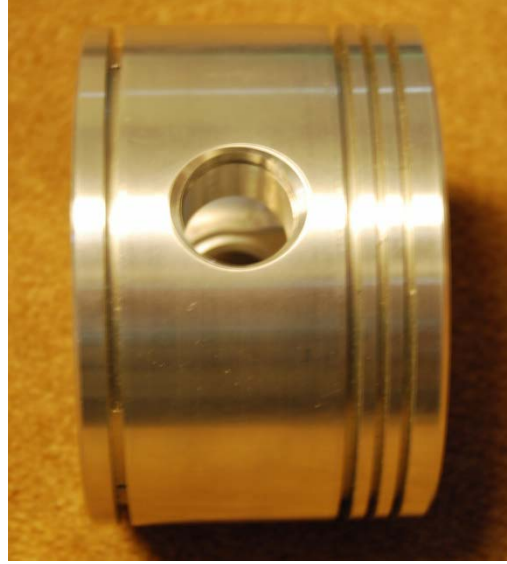
The following pictures are of a replacement piston.

I finally chose to use extruded stock with an appropriate thermal coefficient of expansion and carve the pistons using Computer Numerically Controlled (CNC) milling. Using extruded stock provides for uniform grain structure much improved over even the legitimate cast original pistons.

The trick to keeping this within scope is to follow the original design as closely as possible and explain how the very few deviations could have no effect on design and operational integrity. The biggest deviation was the alloy used. That proved to be no problem since the thermal coefficient of expansion was the same and all other strength parameters were better than the original. Still, there are a lot of design aspects that had to be explicitly addressed with reasonable arguments and evidence to back up the claims of "at least as good as" the original piston.
